Geotechnical Investigation

**SE Reinig Road Embankment Failures
Slope Stability Analyses
Project NO. 1132628**

April 2019

RE: **SE Reinig Road Embankment Failures**
Slope Stability Analyses

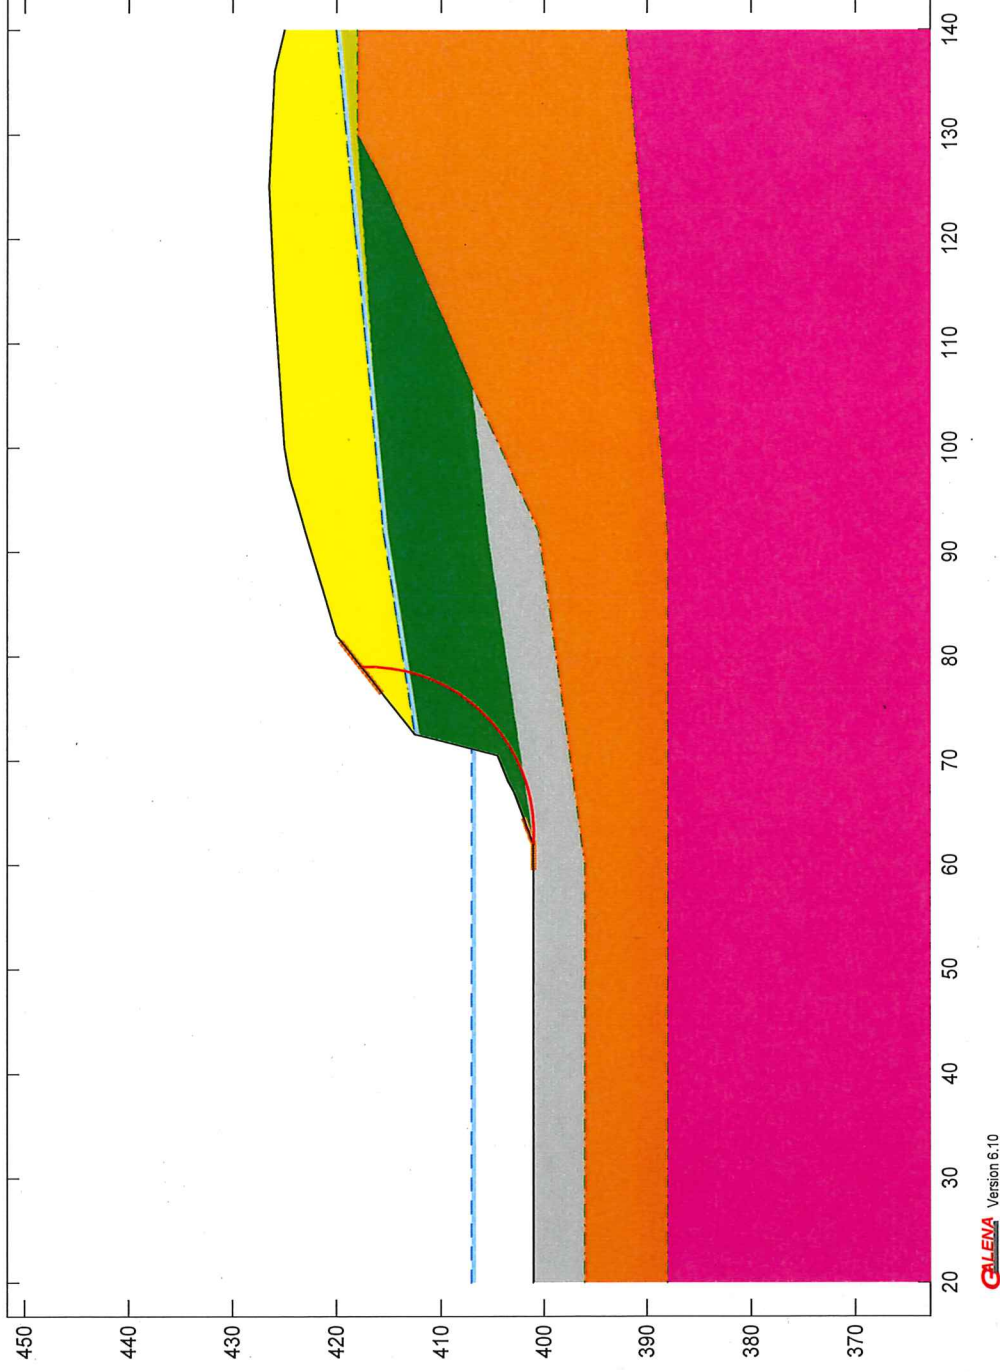
Figure: B-2

For this site, the embankment soils consist of silty sand/sandy silt and silty gravel. For instantaneous drawdown condition modeling, we assumed that for every foot of river drawdown, the water level in the soil would drop at a rate of about 0.75 feet. For modeling, we chose a high water condition of Elevation 428.4 feet (NAVD88) and a post storm river elevation of 407 feet (NAVD 88). This creates a conservative head differential of 5.5 feet between the contact soil and the river. Based on our analyses, the instantaneous drawdown condition FS for the existing critical cross section under these assumed conditions is 0.62.

Table 3: Existing Slope Modeled Factors of Safety			
Modeled Condition	FS	Target FS	Figure
Low Flow	1.06	1.3	B-1
Drawdown	0.62	1.1 to 1.3	B-2

Project Reing Road: Existing Condition Section C-C
Drawdown

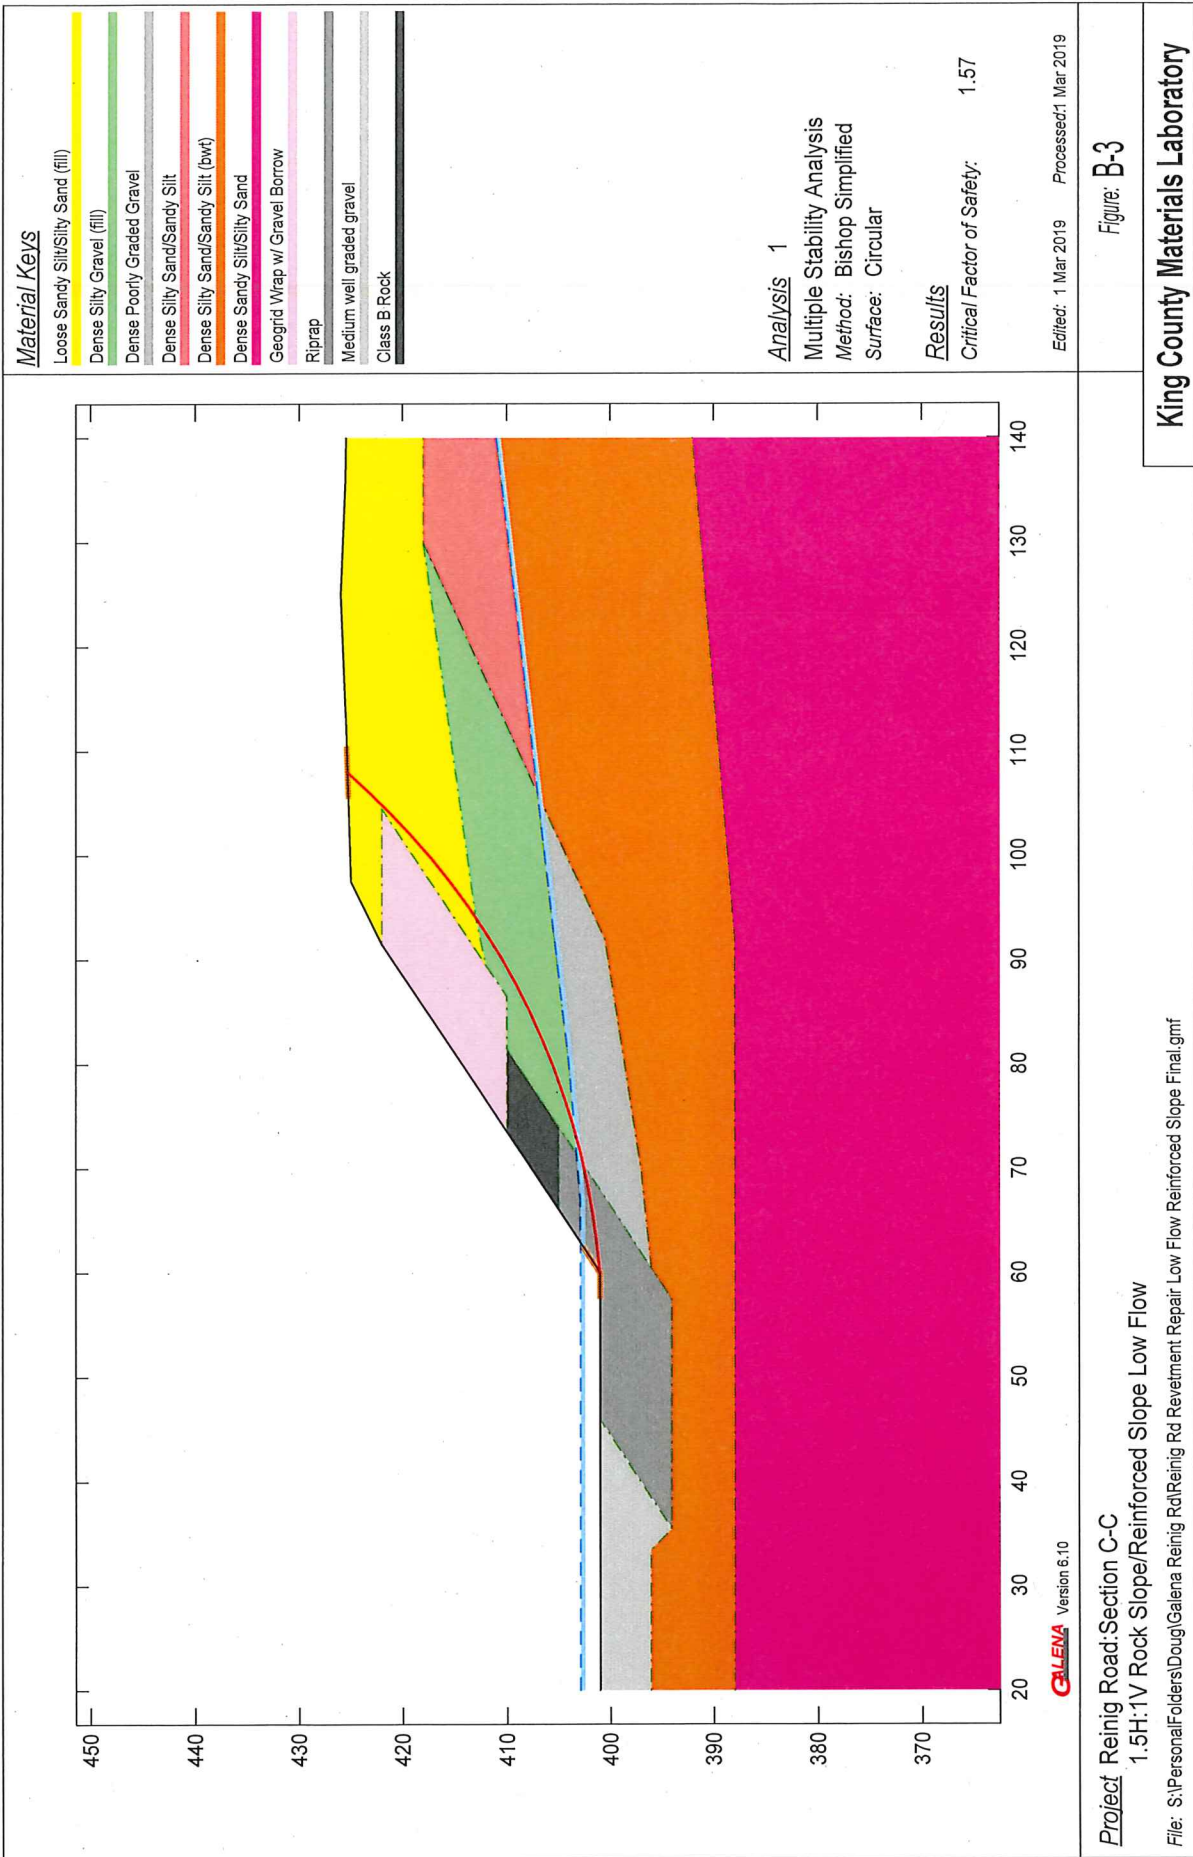
Table 5: Typical Mitigation Sections Modeled Factors of Safety (Static)				
Section	Modeled Condition	FS	Target FS	Figure
ELJ/1.5H:1V Slope	Low Flow	1.57	1.3	B-3
ELJ/1.5H:1V Slope	Drawdown	1.42	1.1 to 1.3	B-4
1.5H:1V Rock Slope	Low Flow	1.54	1.3	B-5
1.5H:1V Rock Slope	Drawdown	1.37	1.1 to 1.3	B-6

Project Reing Road: Section C-C
1.5H:1V Rock Slope/Reinforced Slope Low Flow
File: S:\Personal\Folders\Doug\Galena Reing Rd\Reing Rd Revetment Repair Low Flow Reinforced Slope Final.gmf

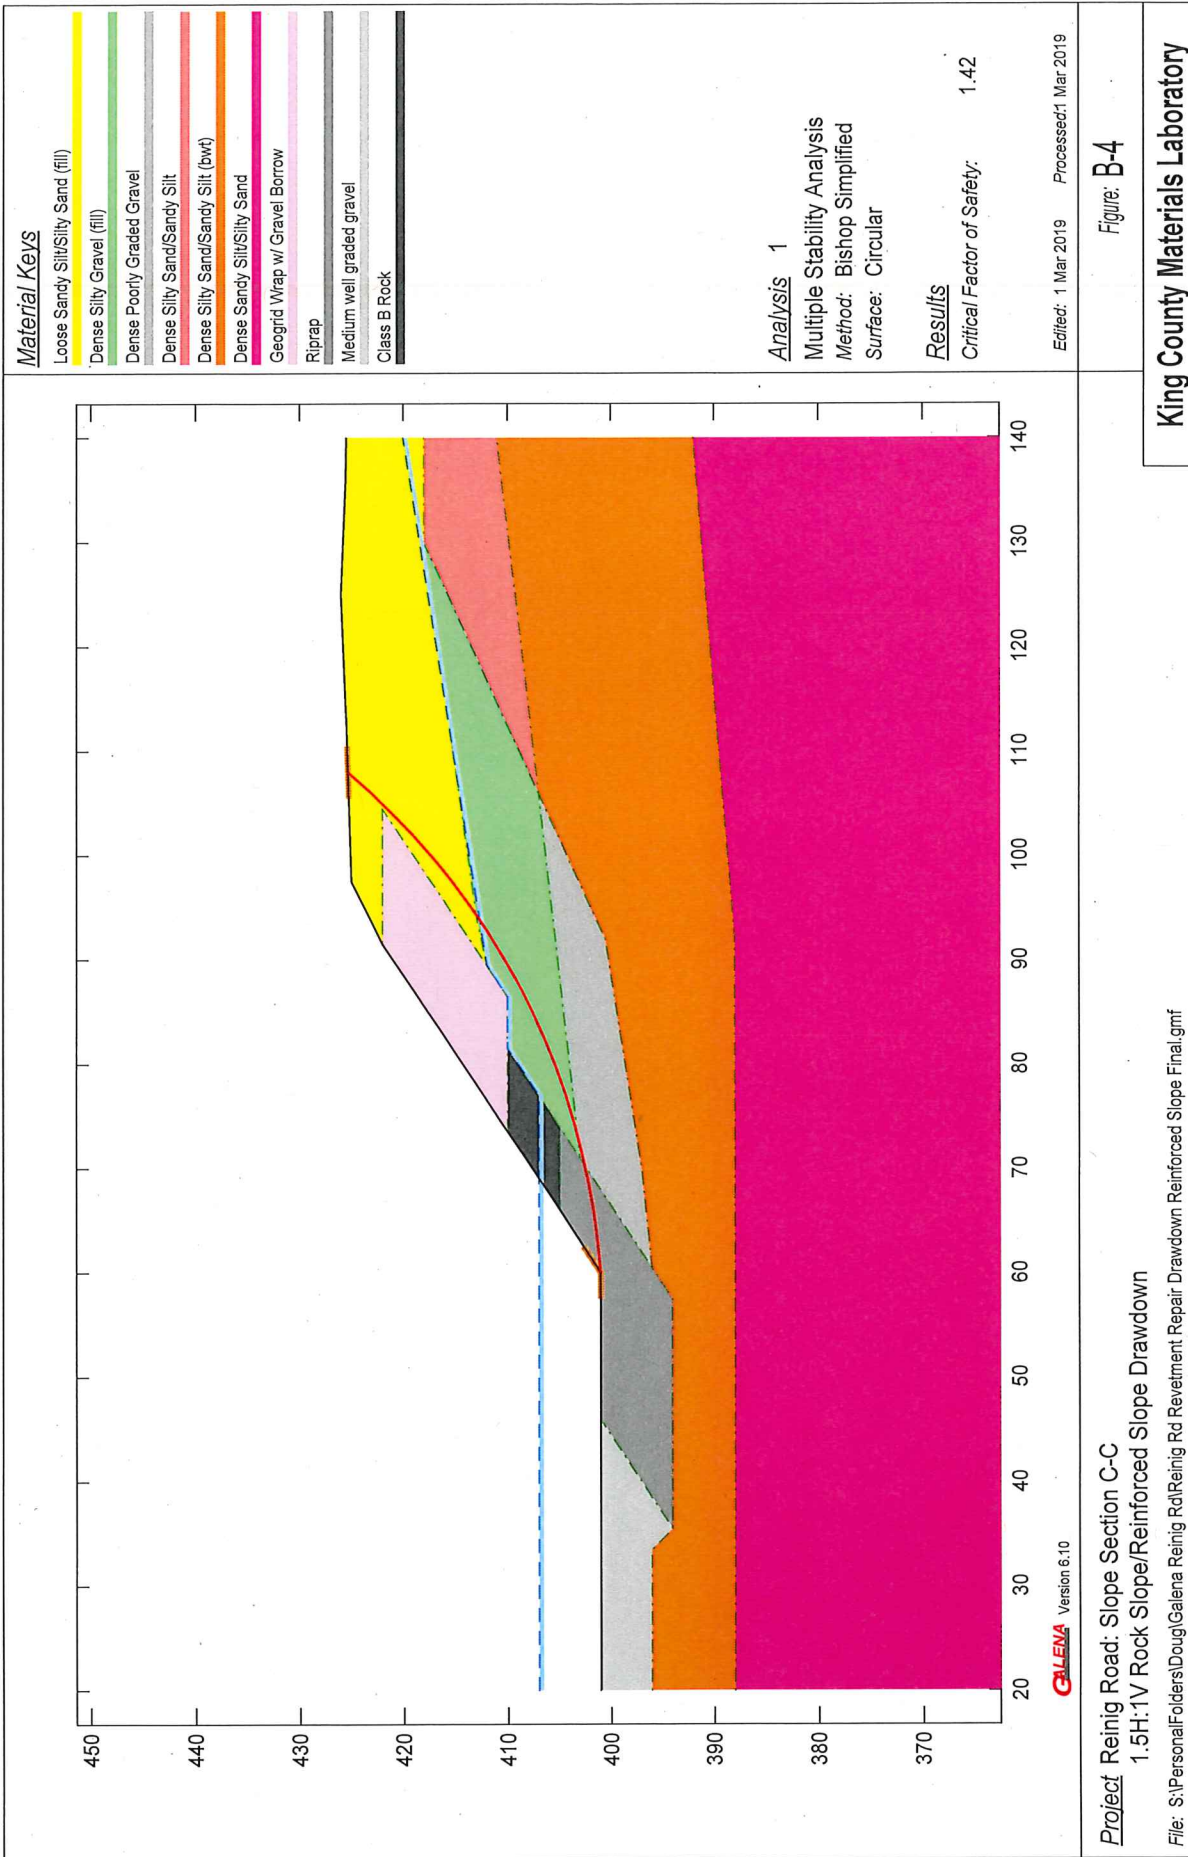
Project Reinig Road: Slope Section C-C
1.5H:1V Rock Slope/Reinforced Slope Drawdown
File: S:\Personal\Folders\Doug\Galena Reinig Rd\Reinig Rd Revetment Repair Drawdown Reinforced Slope Final.gmf

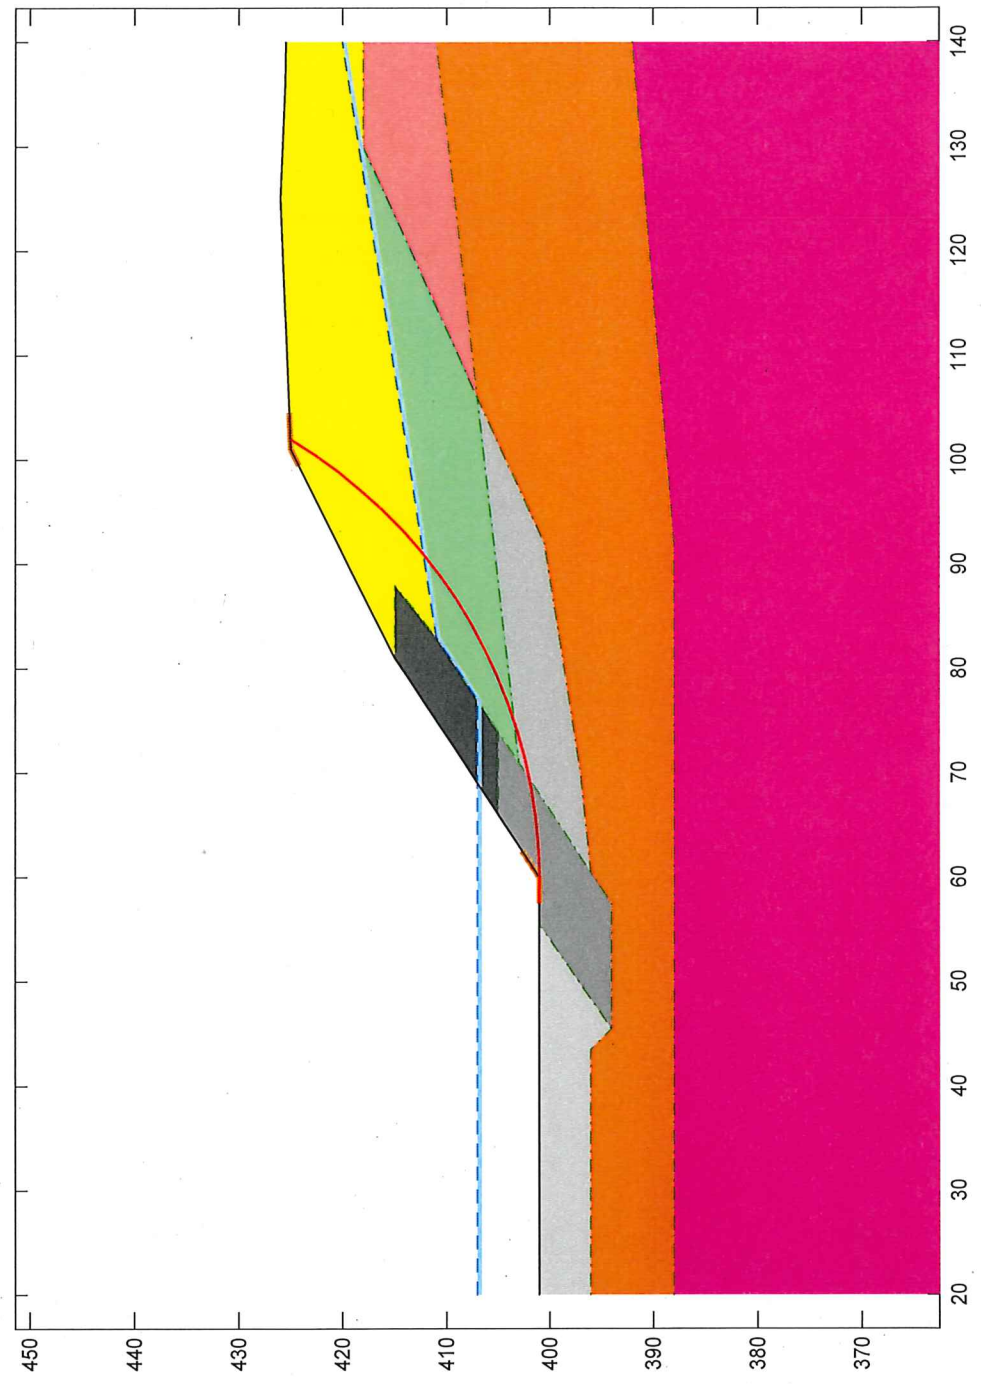
Figure: Figure B-6

Project Reing Road: Slope Section C-C
1.5H:1V Rock Slope/2H:1V Upper Soil Slope Drawdown
File: S:\Personal\Folders\Doug\Galena Reing Rd\Reing Rd Revetment Repair Rock Slope Final Drawdown.gmf

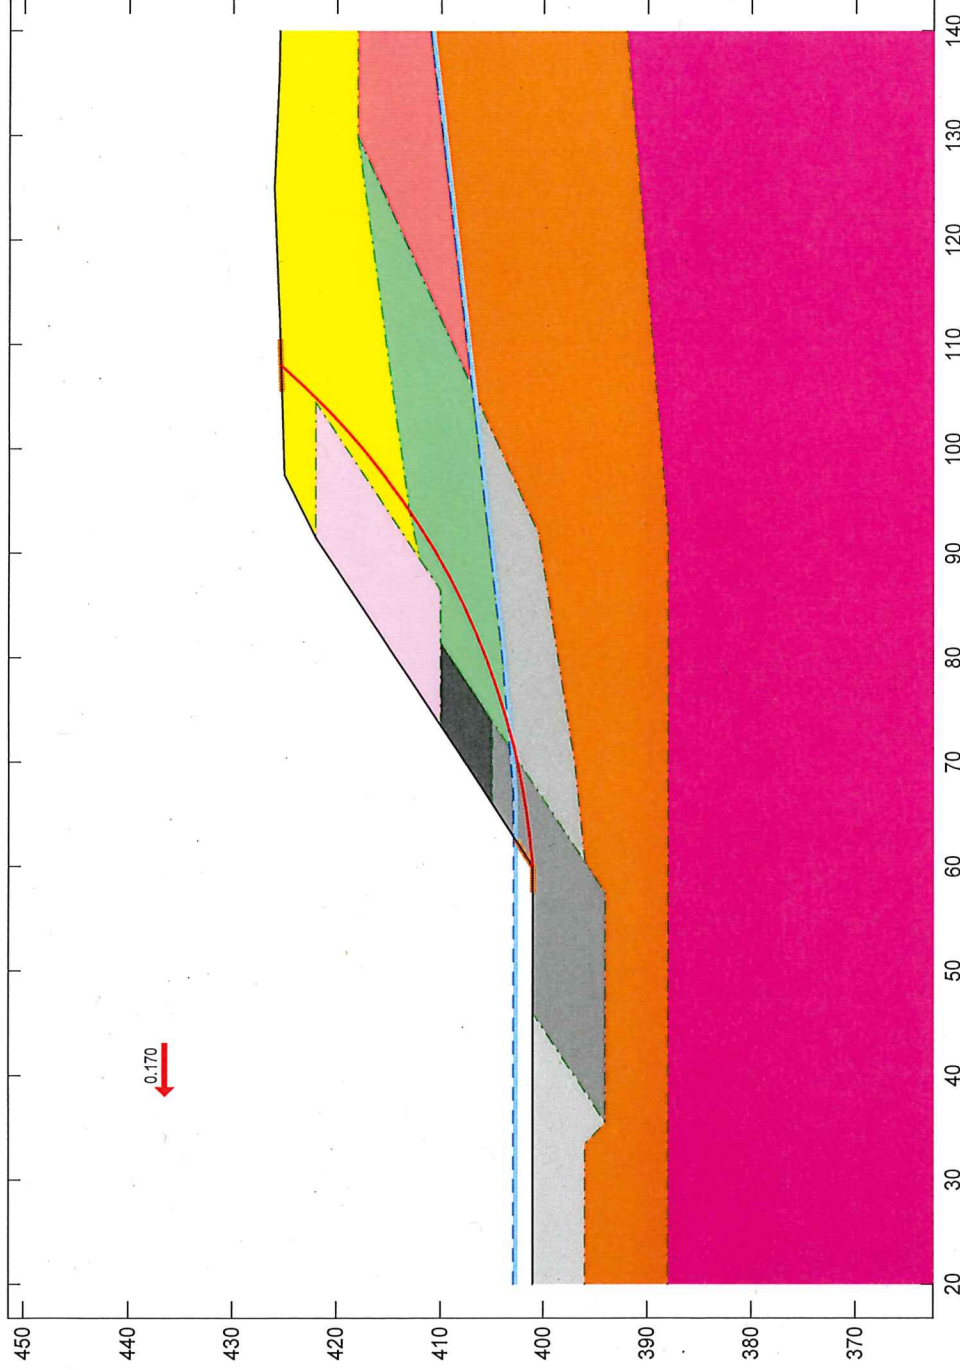
Table 6: Typical Mitigation Sections Modeled Factors of Safety (Seismic)				
Section	Modeled Condition	FS	Target FS	Figure
ELJ/1.5H:1V Slope	Low Flow	1.11	1.1	B-7
1.5H:1V Rock Slope	Low Flow	1.10	1.1	B-8

File: S:\Personal\Folders\Doug\Galena Reing Rd\Reing Rd Revitment Repair Low Flow Reinforced Slope Final Seismic.gmf

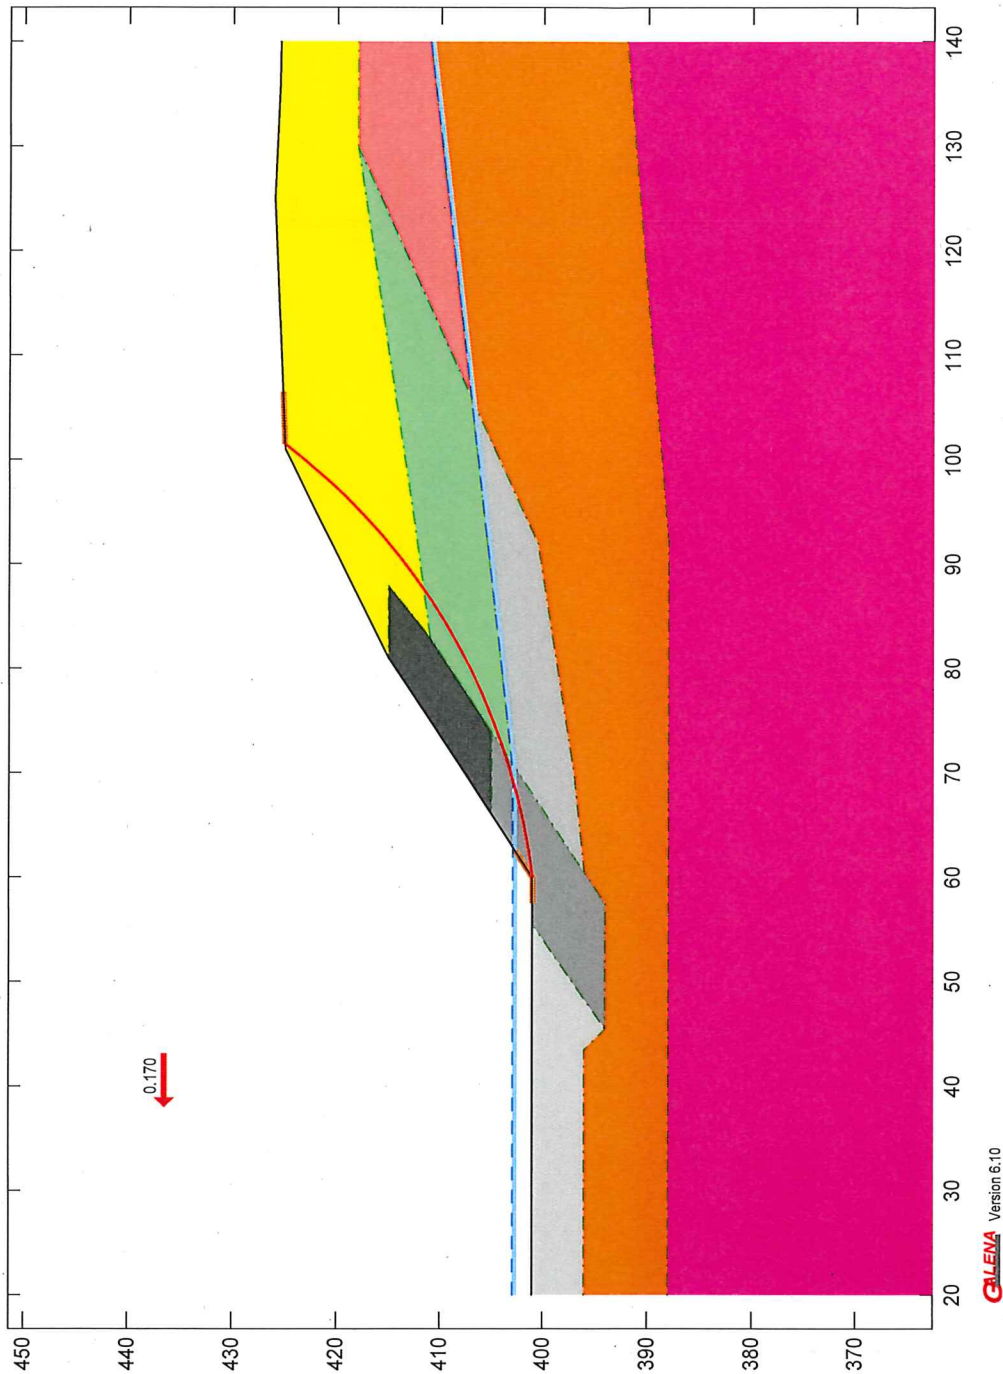
File: S:\Personal\Folders\Doug\Galeana Reing Rd\Reing Rd Revetment Repair Rock Slope Low Flow Final Seismic.gmf
